**SOILS AND FOUNDATION
REPORT – ADDENDUM**

**CRAGGY GARDENS SLOPE
INVESTIGATION**

REHABILITATION OF PARK ROADS
FOR BLUE RIDGE PARKWAY
YANCEY AND BUNCOMBE
COUNTIES, NORTH CAROLINA

PRA-BLRI 2P14
CONTRACT NO. DTFH71-02-D-00004
TASK ORDER 0003

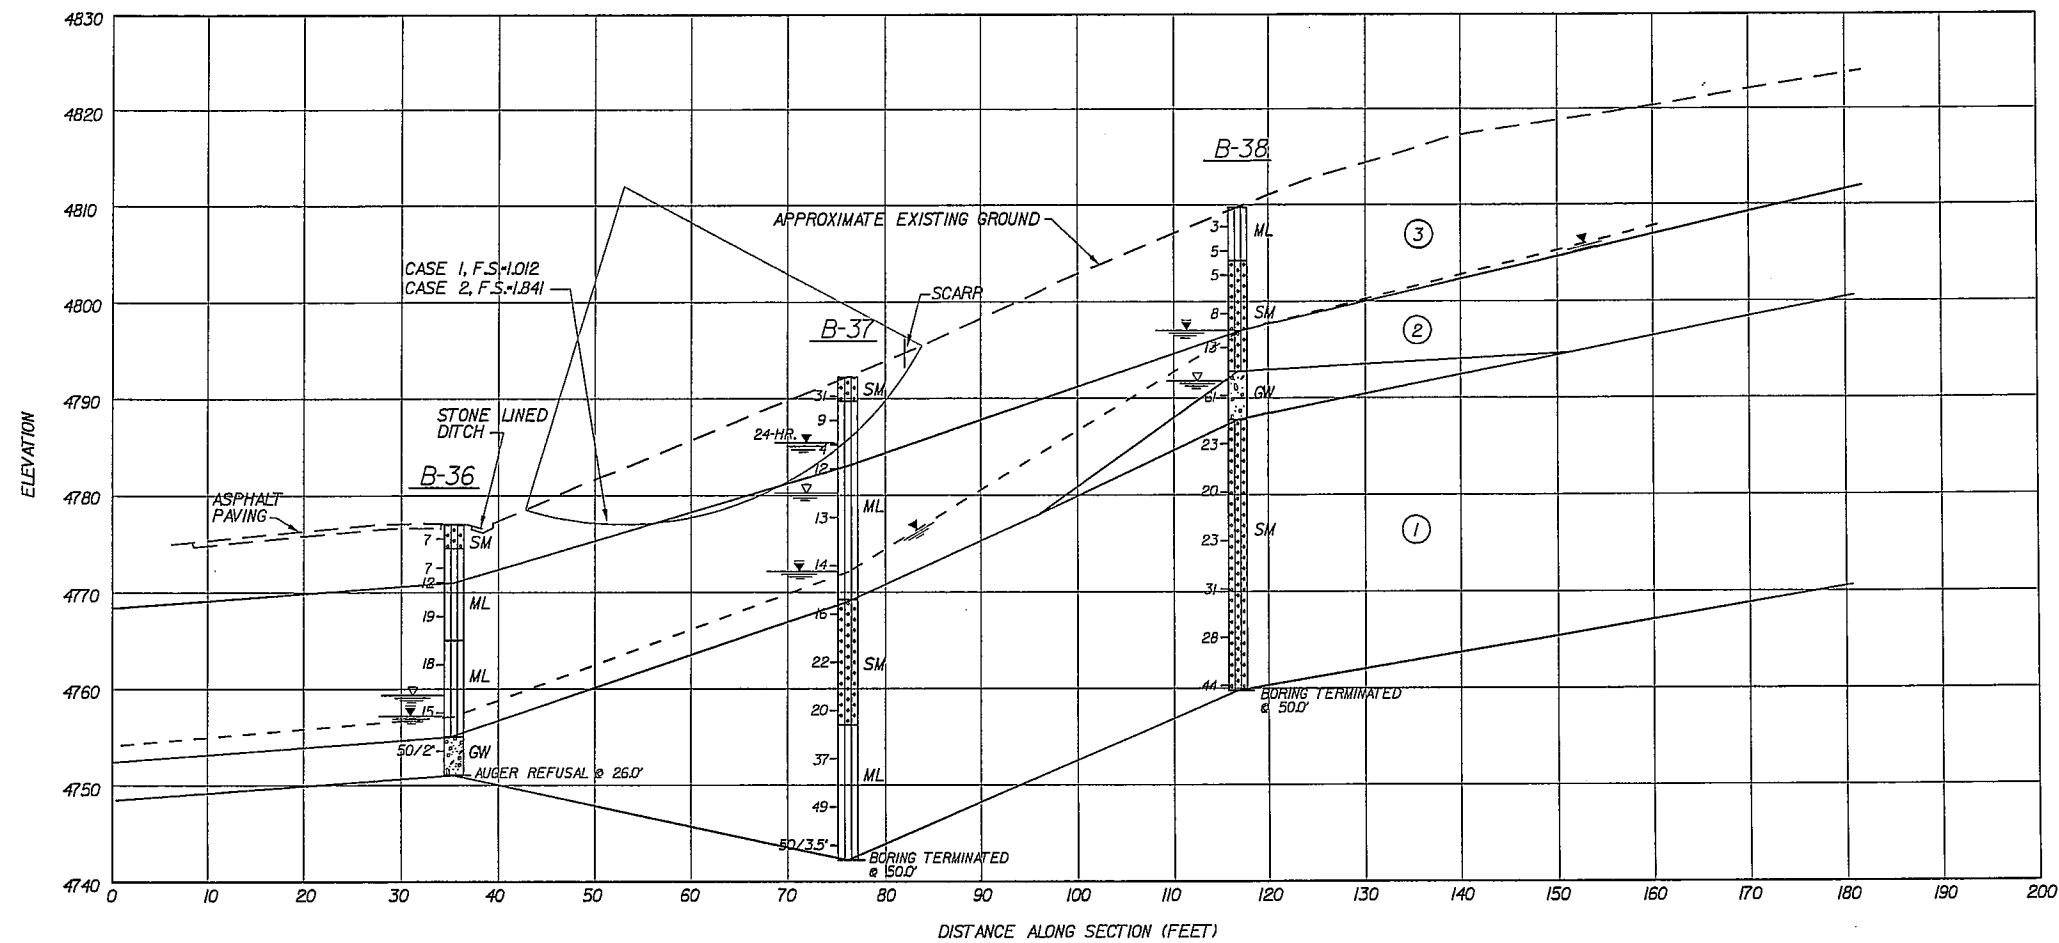
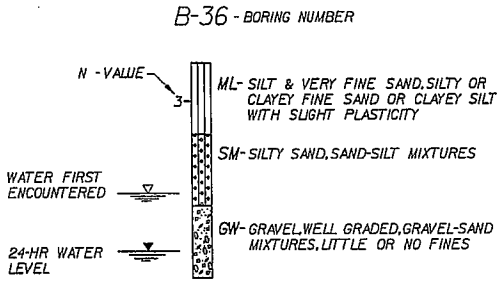
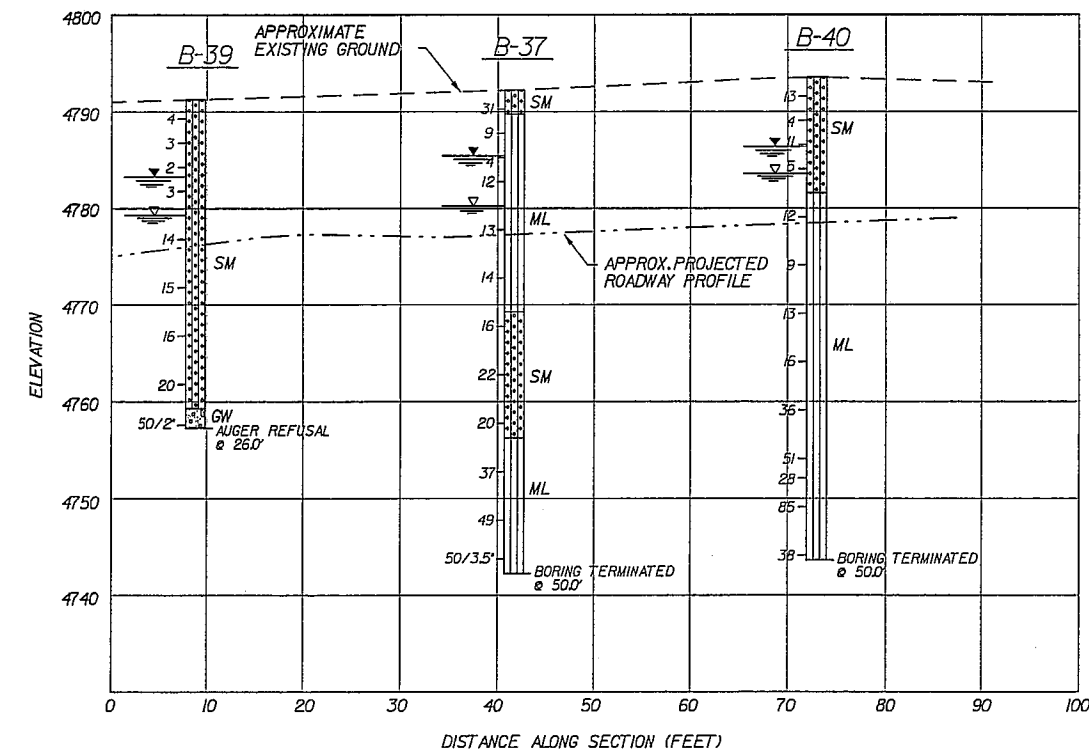
SLOPE INVESTIGATION AT
CRAGGY GARDENS
PICNIC ACCESS AREA
SECTIONS A AND B
FIG. 3

SOIL PARAMETERS				
NO.	DESCRIPTION	UNIT WEIGHT	SHEAR STRENGTH	
			COHESION	FRICTION ANGLE
1	SILTY SAND	120	0	33
2	SILT (ML)	110	100	30
3	ML/SM (LOW N-VALUE)	110	100	26

STABILITY ANALYSIS:
CASE 1 - EXISTING CONDITION
CASE 2 - POST DRAIN

Results of the field investigation were used to develop a typical geologic section through the unstable slope. This is reflected on Figure 3. It is noted that groundwater was encountered within a few feet of the surface within the zone that shear cracking was observed. See borings B-37, 39, and 40. The shear cracking occurred during a period of high rainfall, and high groundwater level is considered the probable cause of the slope instability. Stability analyses were conducted for the typical section using the computer program UTEXAS4. The typical section included an assumed groundwater level at the ground surface. Through an iterative process and based on the location of shear cracks, shear strengths were determined that produced a critical factor of safety of approximately 1.0 for the typical section. This is represented by the Case 1 analysis presented on Figure 3.

Slope stability analyses were again conducted with the same soil shear strengths determined in stability analysis Case 1 and revised groundwater conditions based on installing the collector trenches. This analysis is identified as Case 2 on Figure 3. The Case 2 analysis produced a critical factor of safety of 1.84, which is considered adequate. A seepage analysis was also conducted based on installation of the collector trenches. Calculations are included in Appendix D.

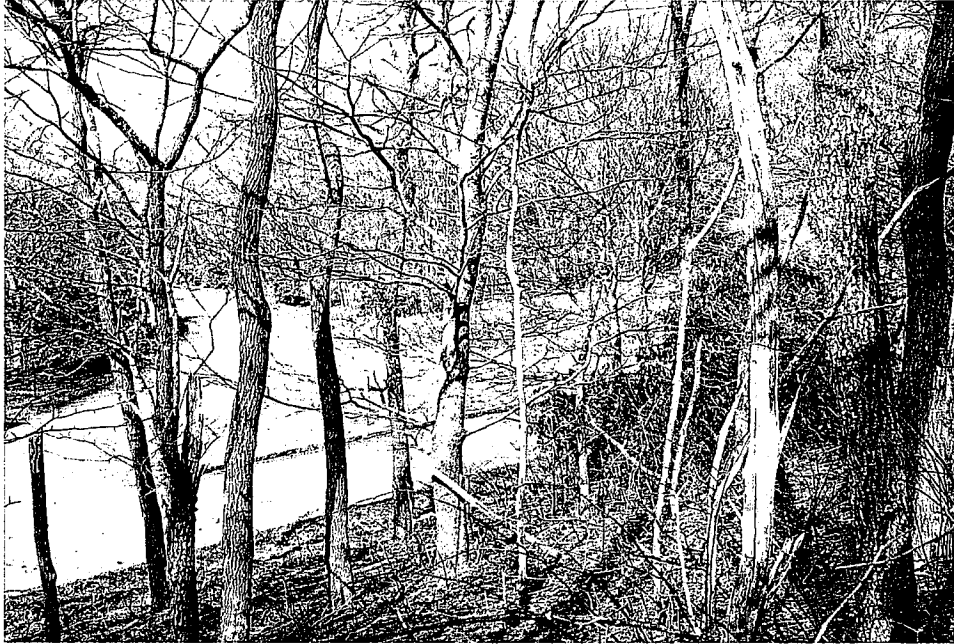
Photo 1. Mid-slope facing
toward Craggy Gardens Access
Road.

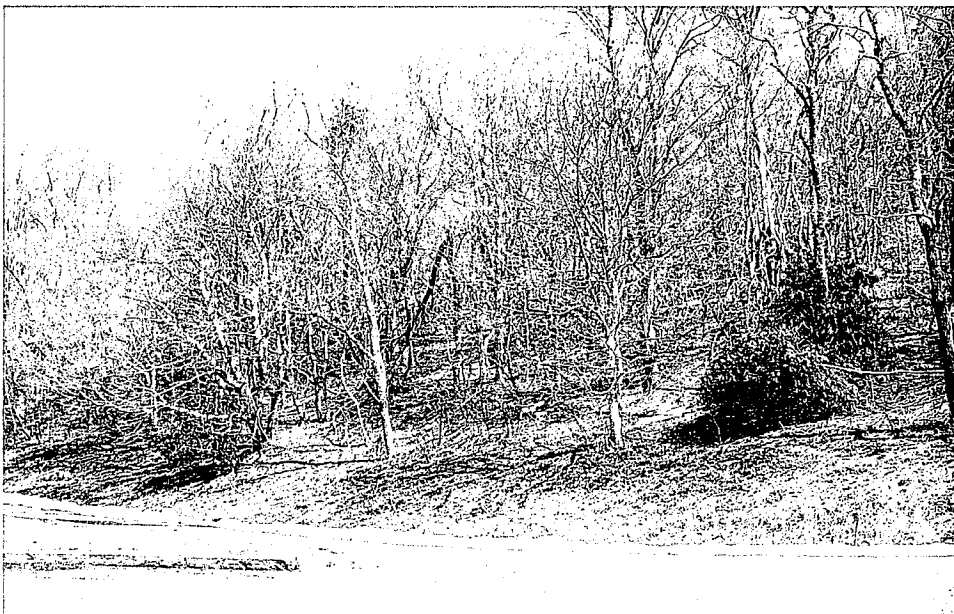
Photo 2. Facing slope from Blue
Ridge Parkway.

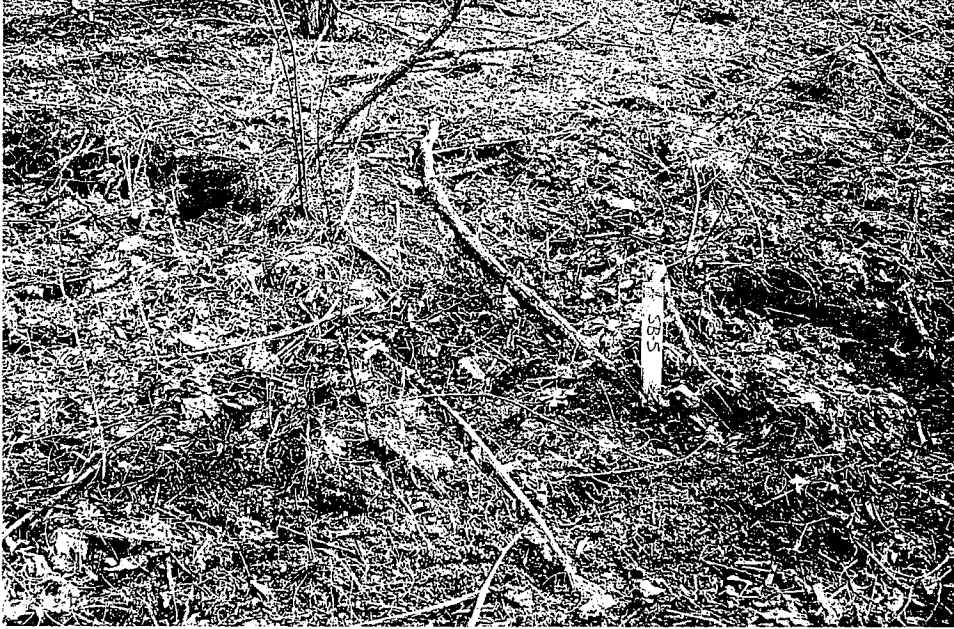
Photo 3. Shear cracks on slope.

ARCADIS was tasked with investigating a potentially unstable slope adjacent the access road to the Craggy Gardens Picnic Area, at Milepost 367.6. This investigation was considered necessary after shear cracks were observed in the slope. Photographs 1 and 2 show the slope and general area of concern. Photographs 3 and 4 show examples of the shear cracks at the ground surface. All photographs are provided in Appendix B.

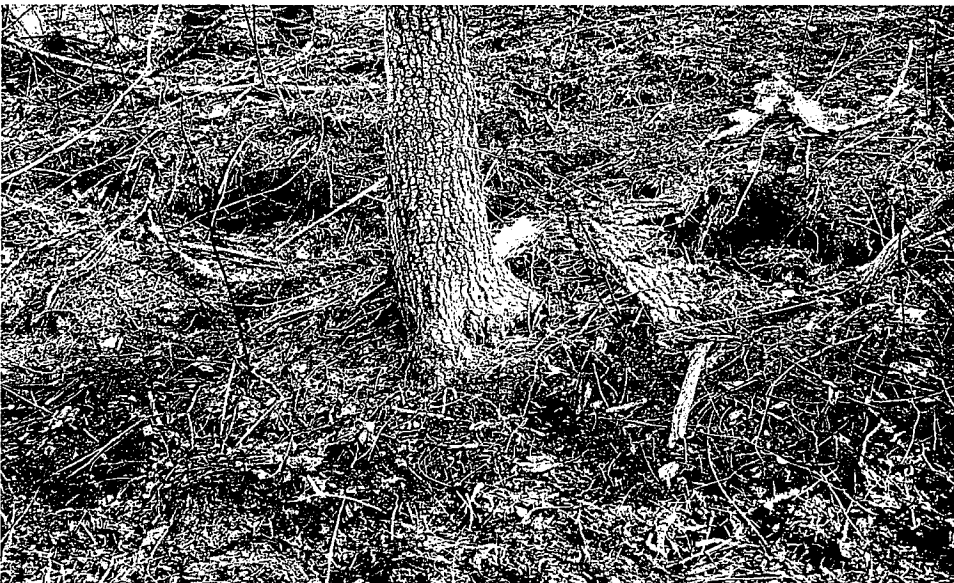
Photo 4. Shear cracks on slope.

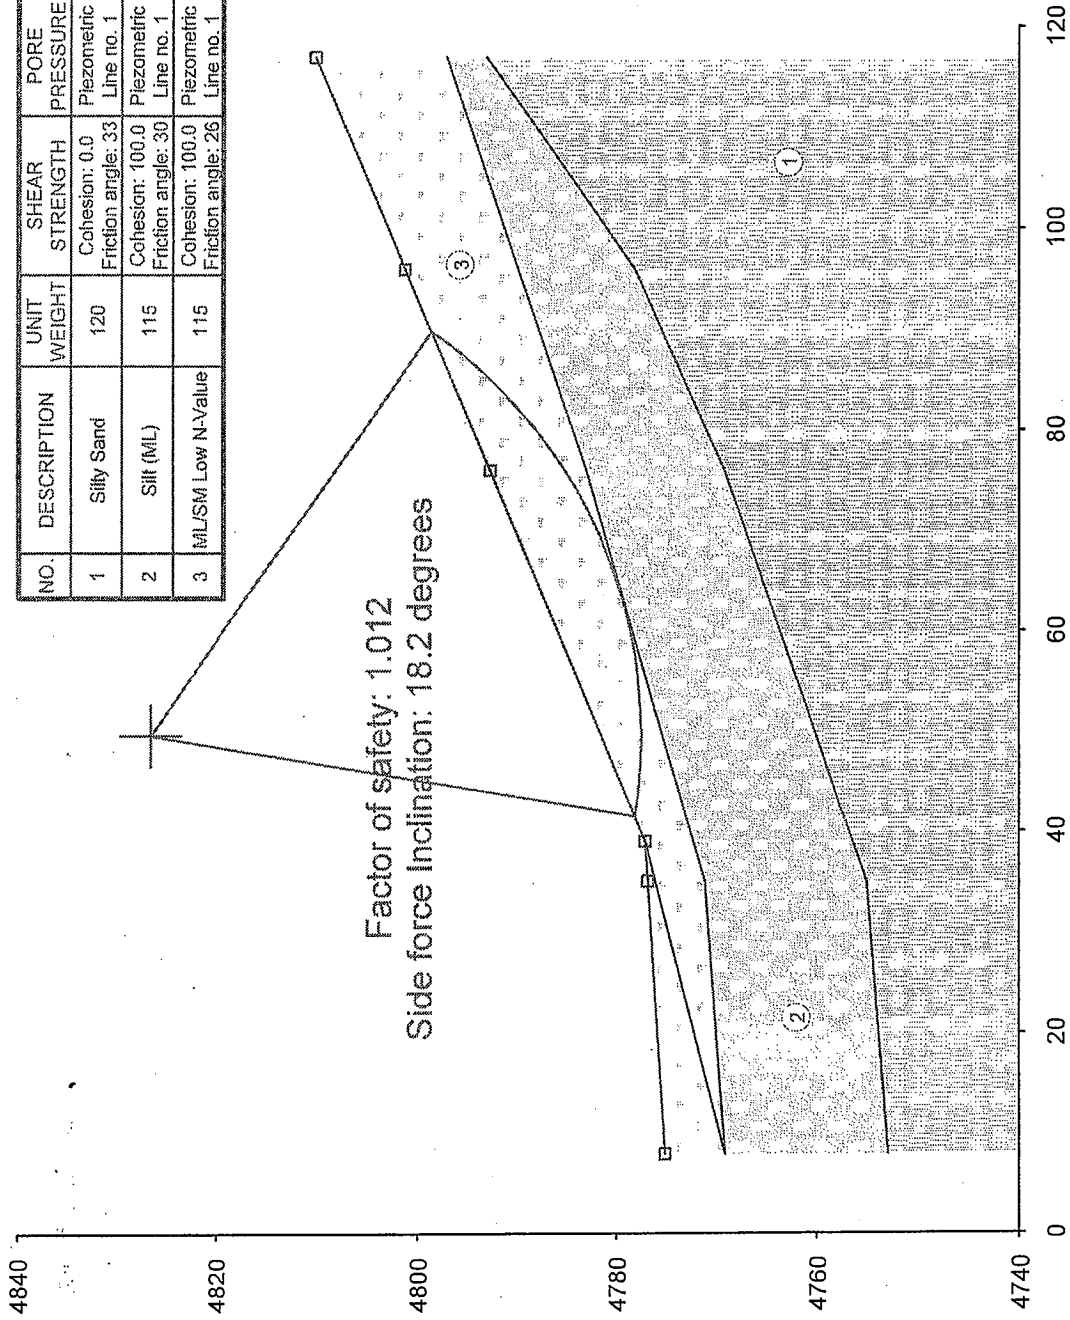
NO.	DESCRIPTION	UNIT WEIGHT	SHEAR STRENGTH	PORE PRESSURE
1	Silty Sand	120	Cohesion: 0.0 Friction angle: 33	Piezometric Line no. 1
2	Silt (ML)	115	Cohesion: 100.0 Friction angle: 30	Piezometric Line no. 1
3	ML/SM Low N-Value	115	Cohesion: 100.0 Friction angle: 26	Piezometric Line no. 1

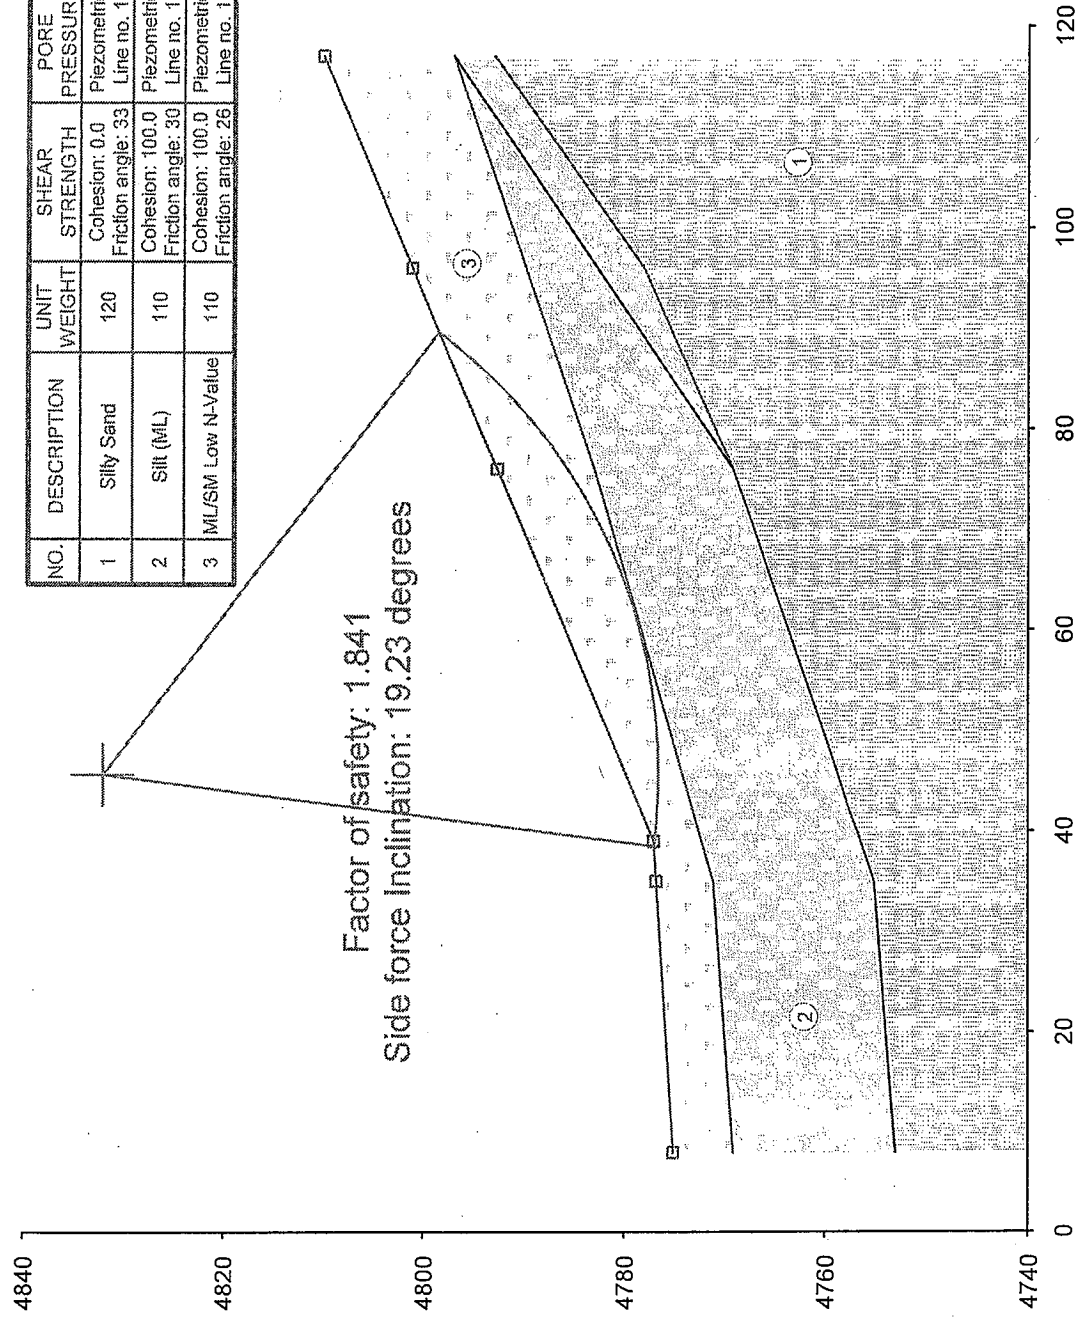
NO.	DESCRIPTION	UNIT WEIGHT	SHEAR STRENGTH	PORE PRESSURE
1	Silty Sand	120	Cohesion: 0.0 Friction angle: 33	Piezometric Line no. 1
2	Silt (ML)	110	Cohesion: 100.0 Friction angle: 30	Piezometric Line no. 1
3	ML/SM Low N-value	110	Cohesion: 100.0 Friction angle: 26	Piezometric Line no. 1

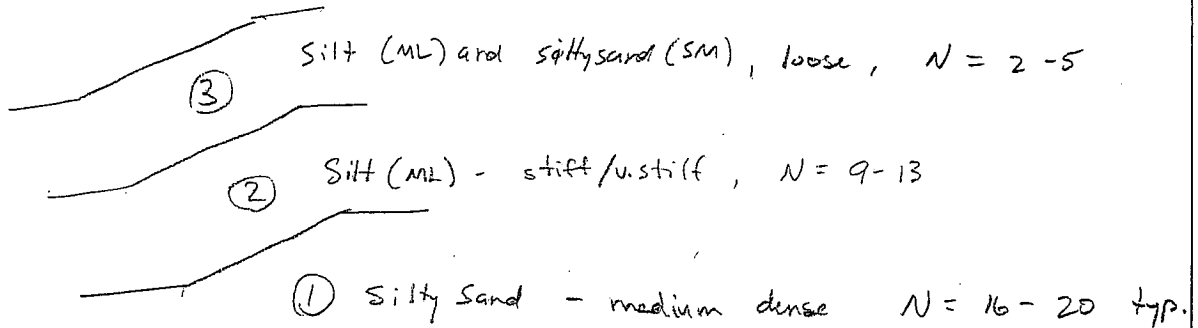
Cross Section

Case 1 - Initial slope Failure

Assume that the slope fails when the groundwater surface is high \rightarrow Factor of safety (F.S.) is approximately 1.0 when slope fails. Limit top of failure circle to approx. location of known scarps.

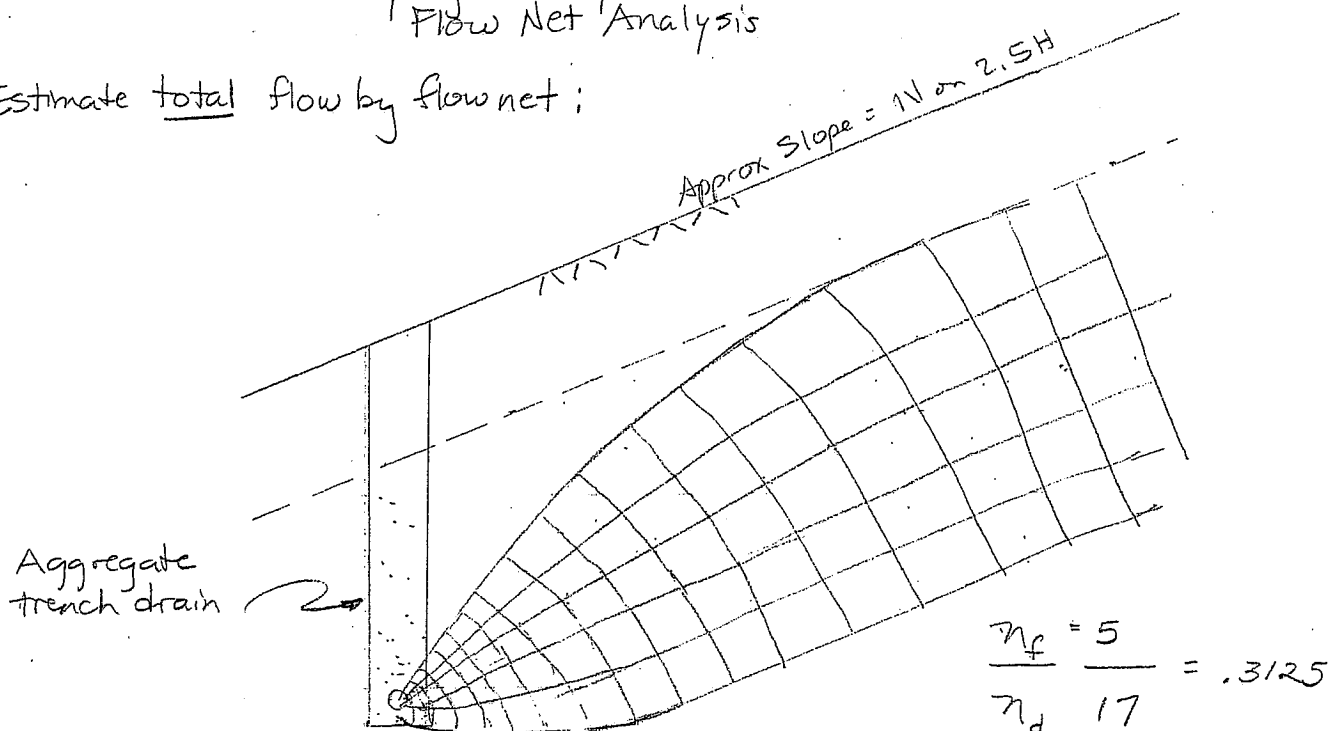
Seepage Rough Estimate Flow Net Analysis

Estimate total flow by flow net:

$$q = kh \left(\frac{n_f}{n_d} \right) \quad \text{where } h = \text{head,} = 7'$$

$k = \text{permeability}$
 $= 10^{-3} \text{ cm/sec (conservative value)}$
 $= 2.835 \text{ ft/day}$
